## CONSTRUCTION GENERAL PERMIT SITE INSPECTION - LEVEL 1 (FOCUSED)

Project Name:	Bremo Power Station	Permit Number:	VAR10H875
Project Address:	1038 Bremo Bluff Road	County/City:	Fluvanna / Bremo Bluff
Project Operator:	Virginia Electric and Power Company	Operator Telephone:	(804)-273-3485
Project Contact:	Mr. Randy Montaperto	Contact Telephone:	(804)-305-1805
Contact E-Mail:	<a href="mailto:Randolph.n.montaperto@dom.com">Randolph.n.montaperto@dom.com</a>	Qualified Personnel (QP):	Mr. Randy Montaperto & Mr. Taylor Engen
Inspector:	Mr. Dustin Staton	Weather (Wet/Dry/Rain):	Sunny, dry, mid 60's
Disturbed Acreage:	4.13 acres	Inspection Date & Time:	April 4, 2016 @ 10:15 a.m.

# CONSTRUCTION GENERAL PERMIT SITE INSPECTION REPORT

## Construction General Permit Site Inspection Photo Log

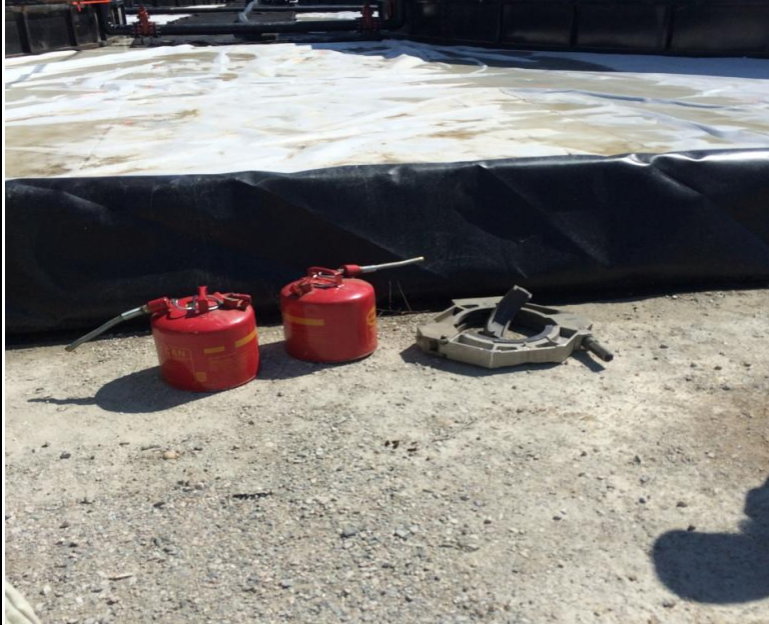
Fuel cans had been used to fuel a small a piece of equipment, and had not been placed back in the proper storage area. (Photo 1)

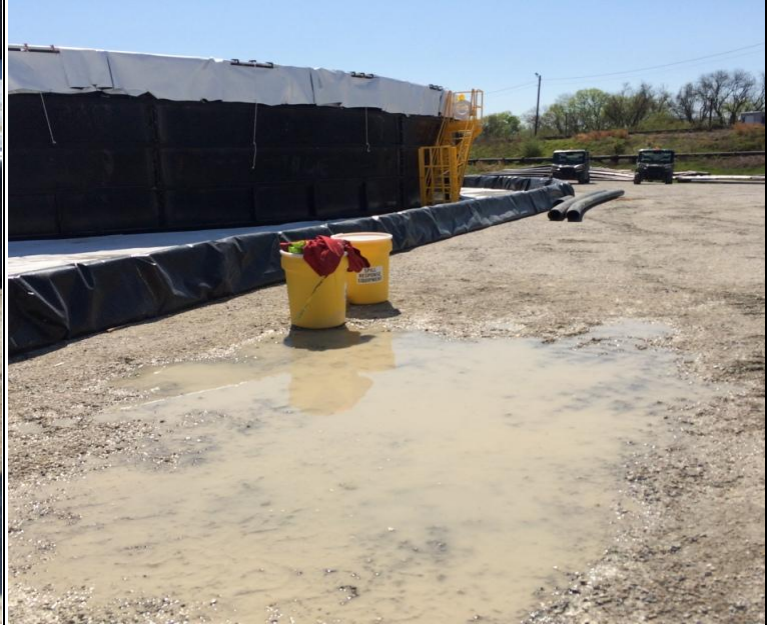
Secondary containment and spill response kit. (Photo 2)

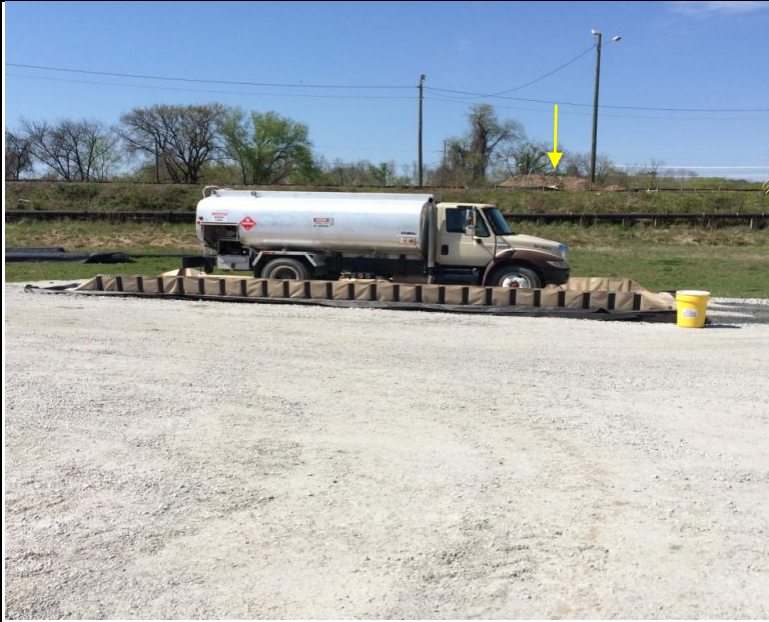
Secondary containment and spill response kit. (Photo 3)  
Denuded soil stockpile behind the fuel tanker.

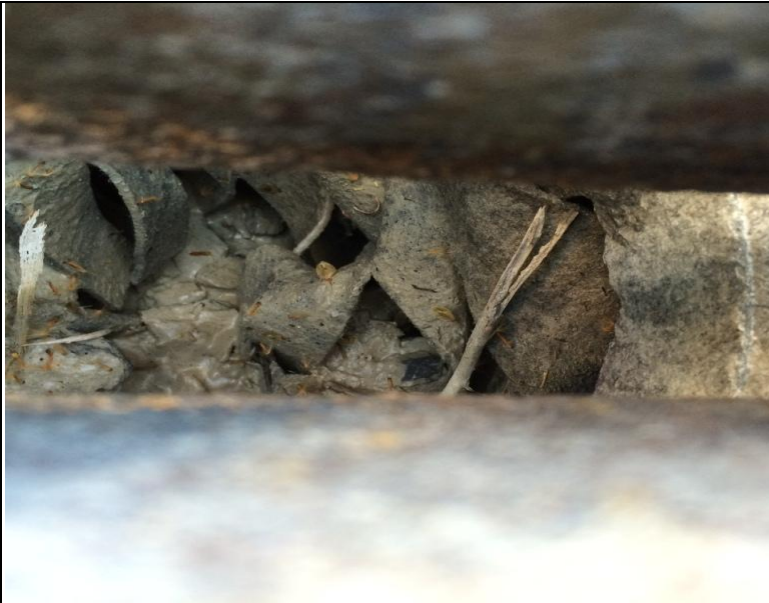
Material, sediment, and debris within the inlet that should be removed. (Photo 5)

Checklist #	Regulatory Citation/Legal requirement <sup>1</sup>	Occurrence	Observation/Legal Requirement/Recommended Corrective Action
4	9VAC25-870-54.C CGP Part II.A.3	Initial	<p><b>Observation:</b> The permitted area has an active ESC plan with Fluvanna County, and the holding tanks are temporary in nature. The site area will be converted back to managed turf once the holding tanks are no longer needed. The existing permitted area was previously a coal pile (impervious), and will be returned to managed turf (pervious) once the project is complete.</p> <p><b>Recommended Corrective Action:</b> Follow the approved plan.</p>
7	9VAC25-870-54.B CGP Part II.E	Initial	<p><b>Observation:</b> Soil related to a smaller adjacent project had been stored within this project's area. The soil was contained with silt fence; however, it had not been stabilized within the appropriate time. Inlet protection was in place and should be maintained.</p> <p><b>Recommended Corrective Action:</b> Either relocate the soil outside of this permitted area or stabilize the soil with seed and mulch. Clean inlet protection. (Photo 4 &amp; 5)</p>

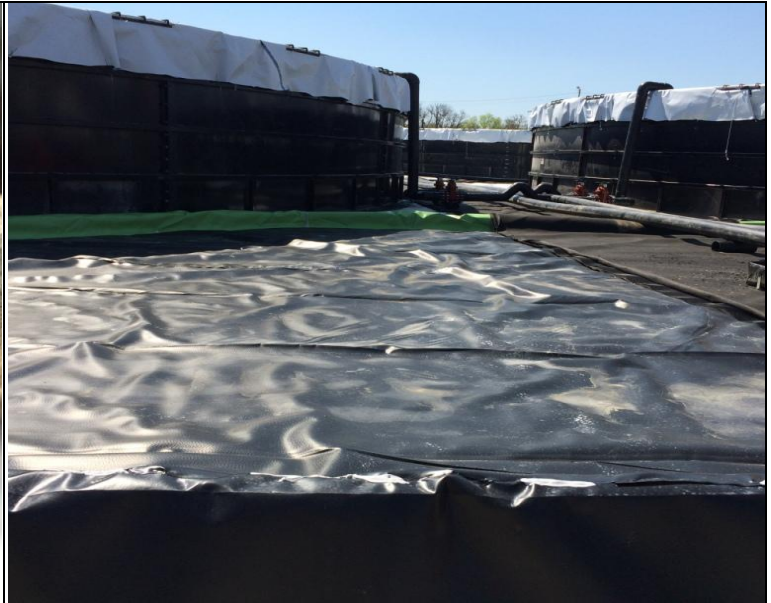
Secondary containment outside of the holding tanks. (Photo 6)

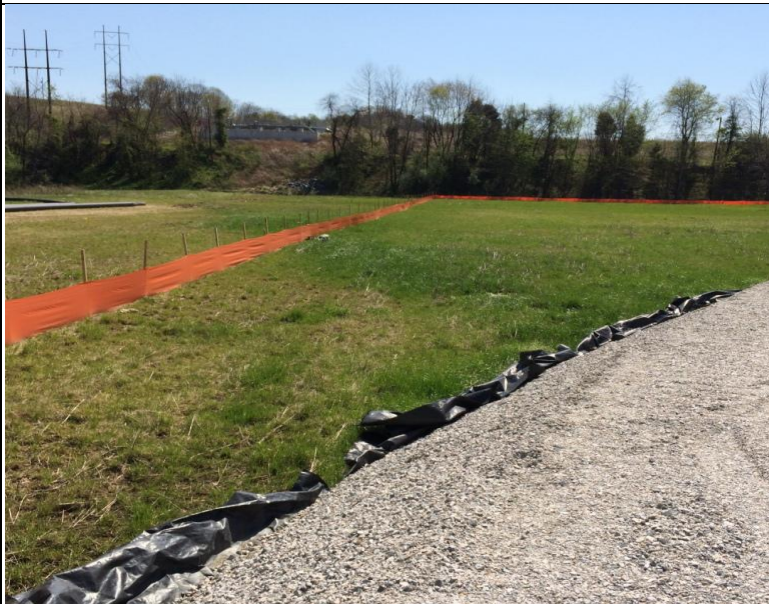
Erosion controls, and geo-membrane beneath the stone base of the holding tanks. (Photo 7)

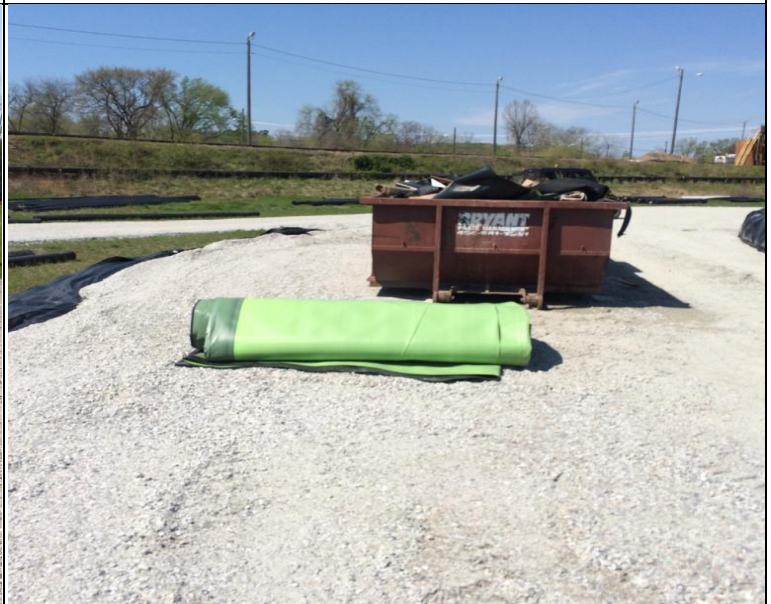
Refuse container, and tarp to prevent the contents from coming into contact with precipitation and becoming a potential source of pollution. (Photo 8)
